Star Motors

Specializing in 300 SEL 6.3's, 450 SEL 6.9's
& 600 Limousines

Quality New & Rebuilt Mercedes-Benz Parts

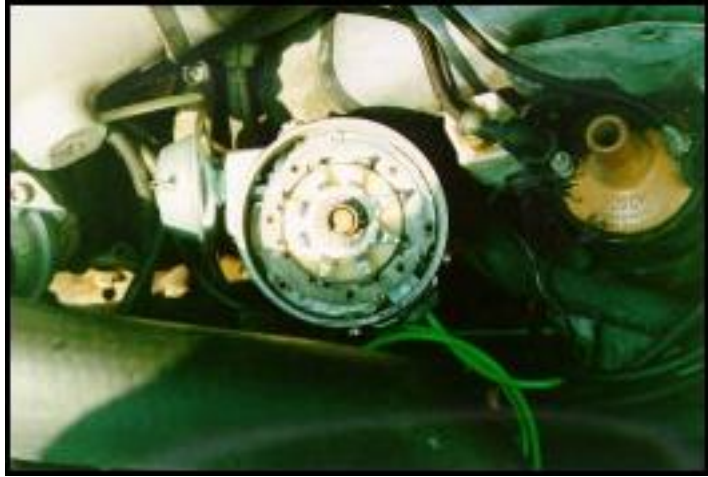
- 2) Rotor installed into # 1 firing position.

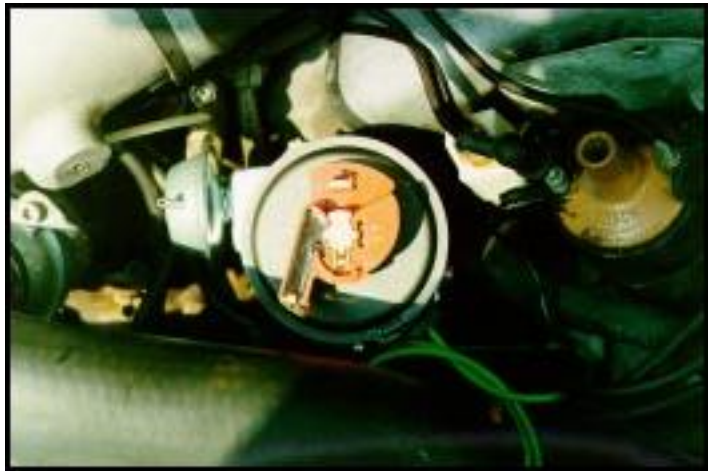
- 3) Remove distributor clamp from old distributor and install on new. Lubricate as shown on shaft and install into distributor housing until rotor lines up with hash mark indicating # 1 position as shown in diagrams 1 and 2.

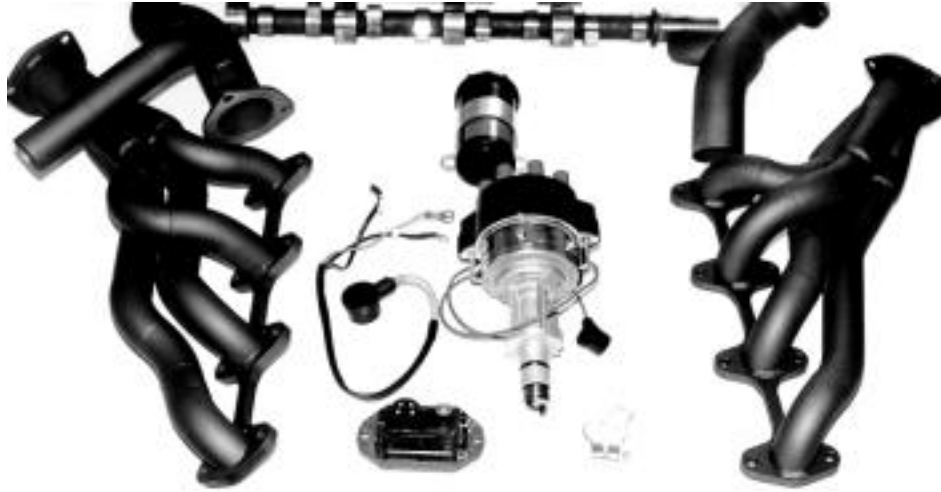
Headers, electronic ignition and camshaft.
